Damage Examples

Summary Damages

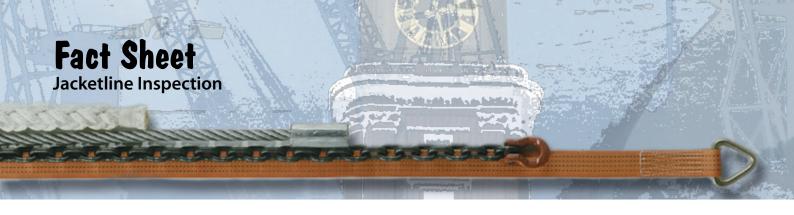
Mild external abrasion of cover, no yarn cut, cover construction still intact

Mild external abrasion of cover, local damage; cover yarn cut, cover construction still intact **Action**

Moderate external abrasion of cover, local damage; cover yarn cut, cover construction still intact *Action*

Moderate external abrasion of cover, local damage; cover yarn cut, cover construction still intact

Inspection of rope after each operation, no further actions needed, mooring rope can still be used *Influence on strength*

Bring the cut cover yarn under the cover, inspection of rope and particularly this area after each operation, mooring rope may still be used

Stop using rope , bring the cut cover yarn under the cover, apply a small seizing, see appendix A *Influence on strength*

Stop using rope, bring the cut cover yarn under the cover, repair the sling with Deltaweb®, see appendix B.

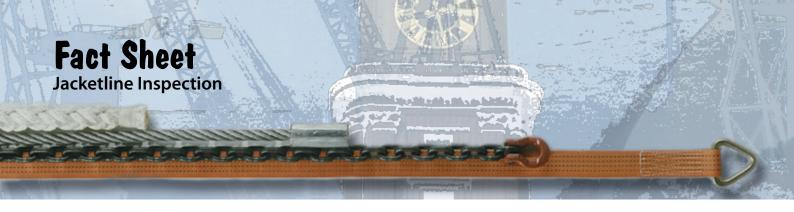
External abrasion of cover, local damage of the cover, load bearing cores come out of the cover **Action**

Cover completely broke, damage noticed on the load bearing cores

Stop using the rope, pull the rope in a straight line, open up the cover, inspect the load bearing cores, depending on the load bearing core damage, repair or discard the rope

Stop using the rope, inspect the load bearing cores (number of cores affected, load history,...), take detailed pictures of the rope and application and send them together with the load history overview to us for a second opinion
